# Inspection Report

123 Main Street  
Tampa FL 12345

**Best Home Inspection & Construction Co. LLC.**

<b>Date:</b> 8/26/2009	<b>Time:</b> 8:20 am	<b>Report ID:</b> DOE 082609
<b>Property:</b> 123 Main Street Tampa FL 12345	<b>Customer:</b> Mr. John Doe	<b>Real Estate Professional:</b> Betty Broker ACME Realty

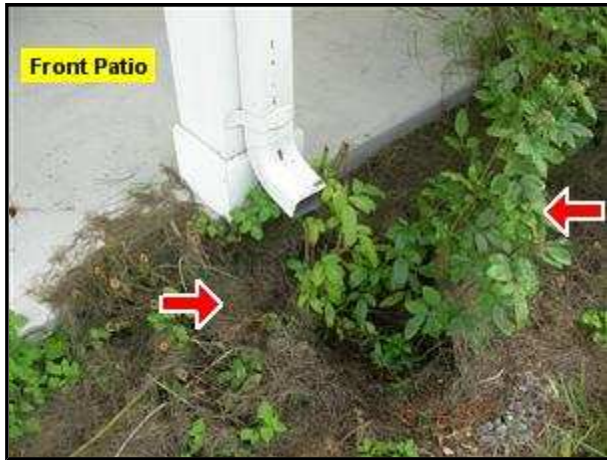
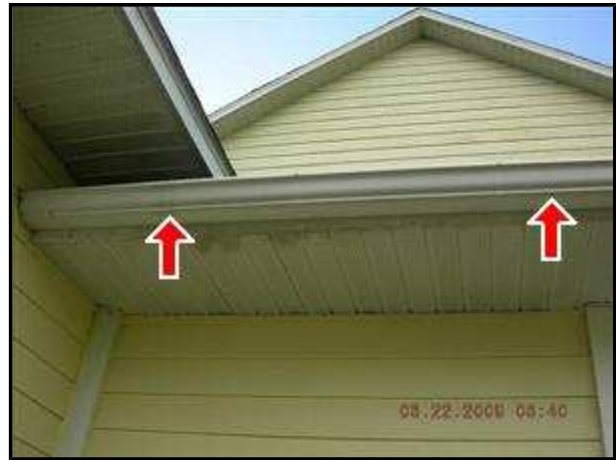
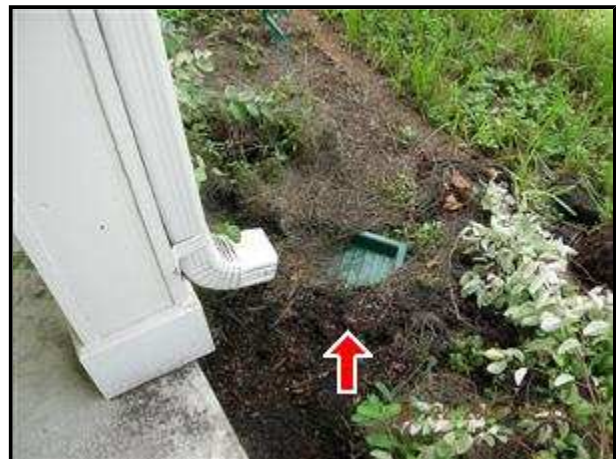
**1.2** We suggest making sure splash blocks are in place where downspouts meet landscaping areas. There were several areas where the splash block was either missing or was not properly positioned. Splash blocks help move rain water away from the foundation and appurtenances around the dwelling which helps prevent settling or deterioration of those components. Also, noticed some dripping coming from gutters in some places. Suggest licensed handyman make sure seams are sealed in gutters. We also suggest that drainage systems be installed at all areas where a higher roof drains onto a lower roof. This will help preserve the normal life expectancy of the roof covering and help prevent leaks at areas of flashing.

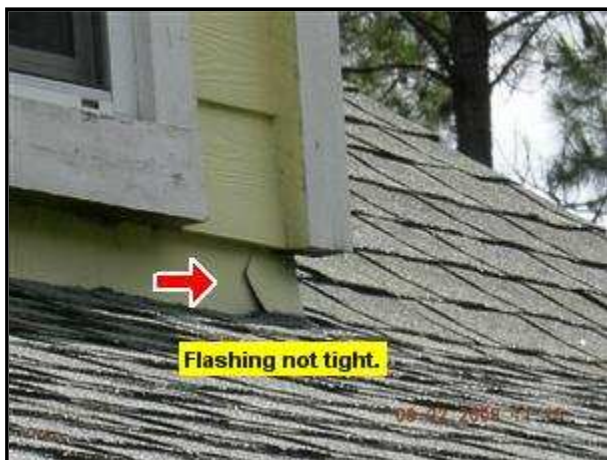
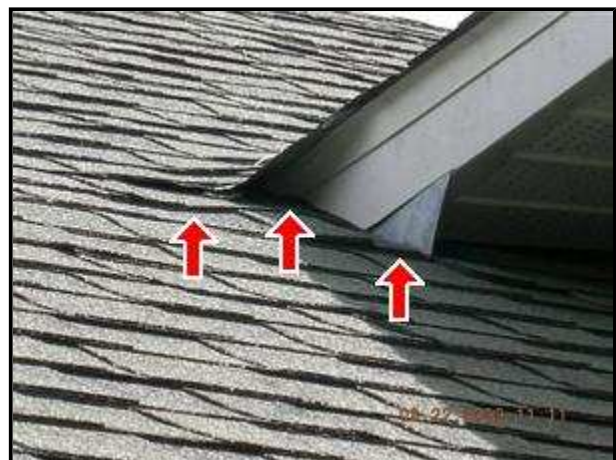
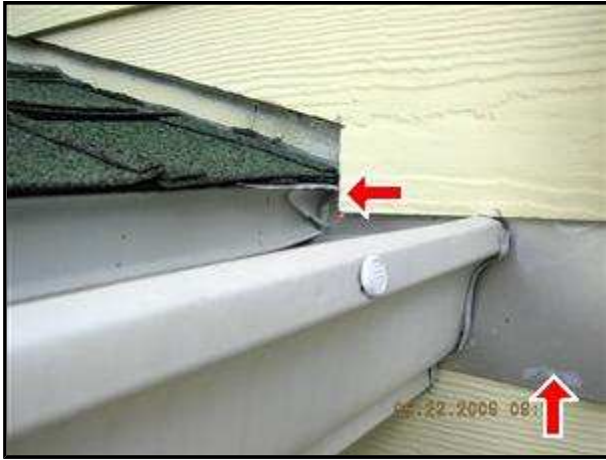
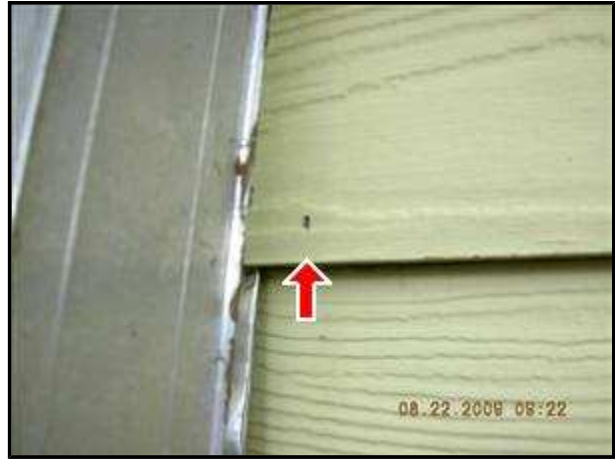
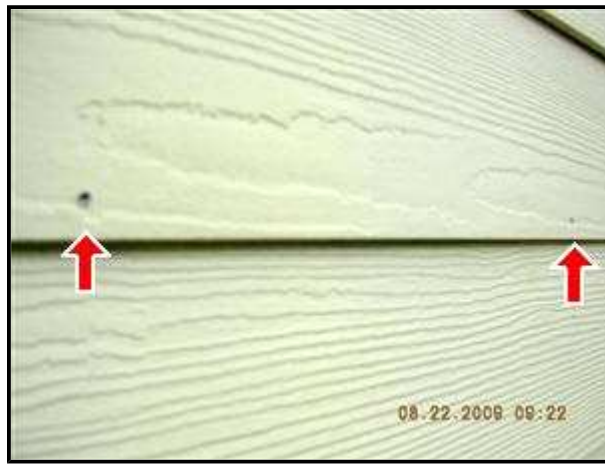
**1.3** Area where top story meets garage roof. Suggest licensed roofing contractor to inspect for water-tightness. New flashing was installed where gutter meets back wall of garage. There is a small spot that should be caulked to prevent moisture from wicking behind siding. The siding has been removed to make that repair. Nail holes are exposed and should be caulked as well.

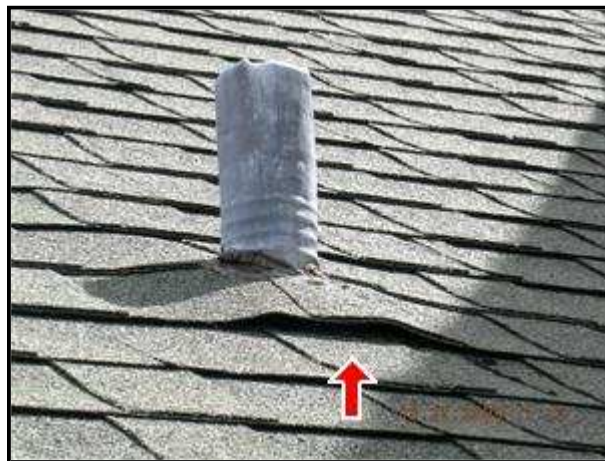
1.4 Picture 1

**1.4** Shingles covering flange of lead boot are raised off of roof. Suggest licensed roofing contractor inspect to determine if gap is allowing any moisture to intrude. This is the plumbing vent stack for the laundry room.

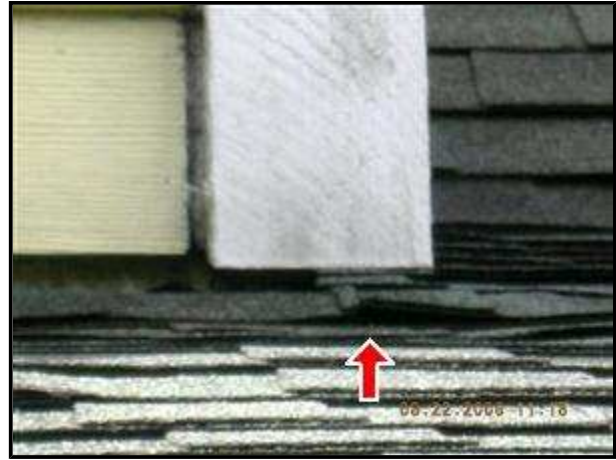
**1.6** Chimney flashing needs repair. Leak from this area has caused damage to patio ceiling below.

Chimney flashing needs repair. Leak from this area has caused damage to patio ceiling below.

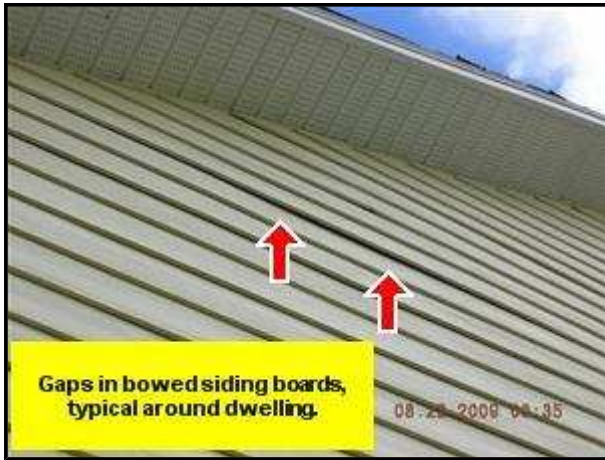
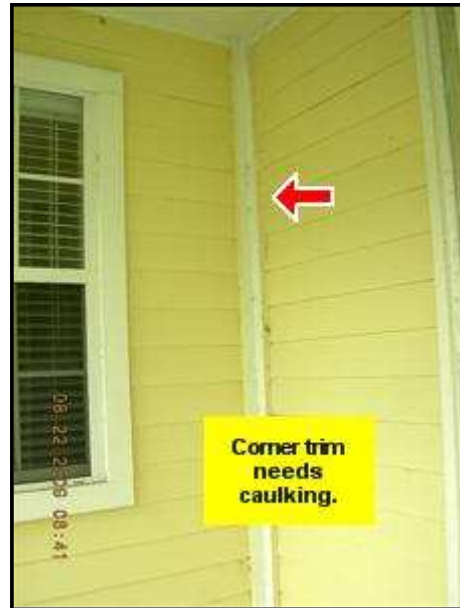
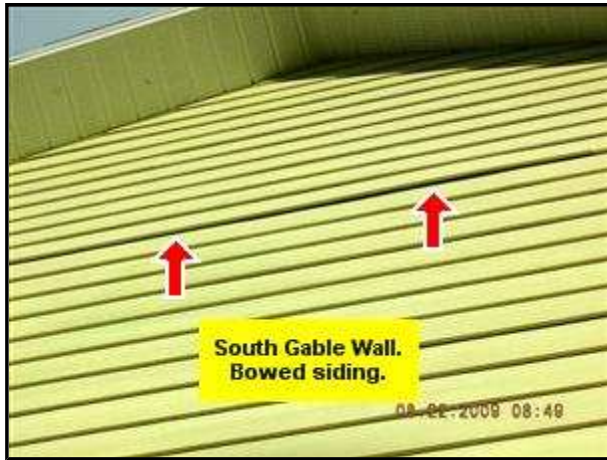
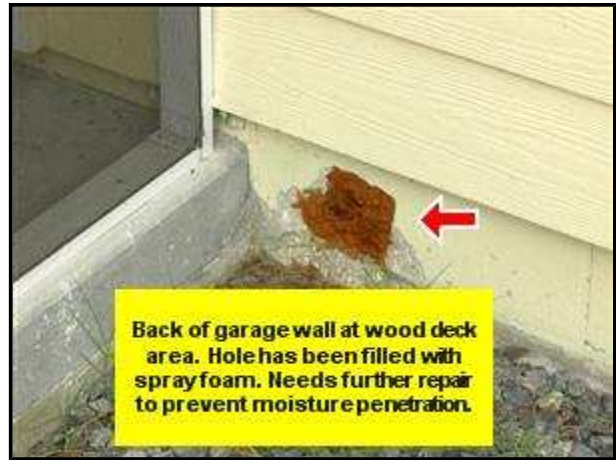
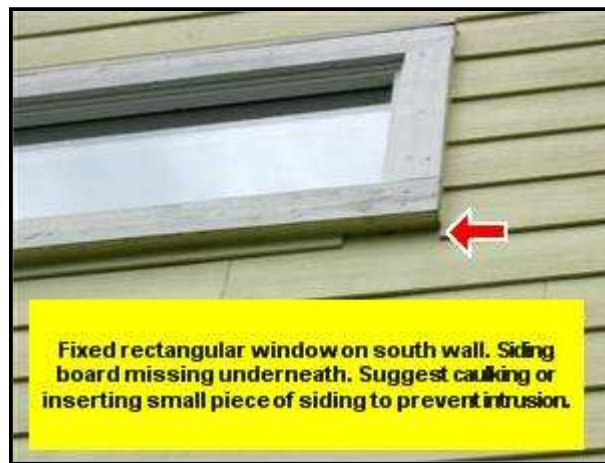
**2.0** As is common with siding, there are some boards which have bowed slightly and visible gaps are evident. While this is not an immediate concern, the siding as a whole should be monitored on an on-going basis. Some spots may need to be caulked to prevent moisture or insect intrusion. Because wood structures tend to expand and contract, there are some areas around window and door openings which need to be caulked and painted. This is general maintenance and can be performed by any competent person.

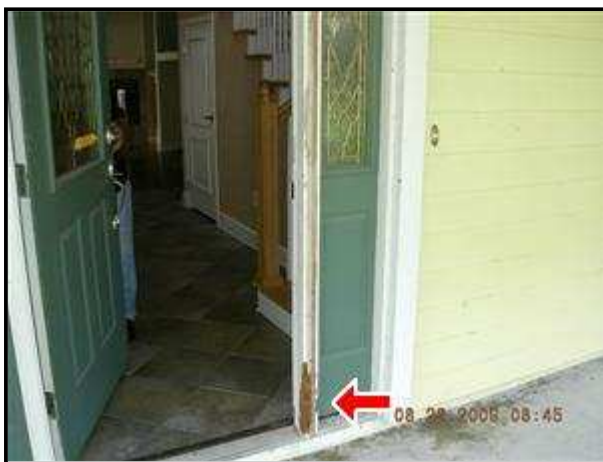
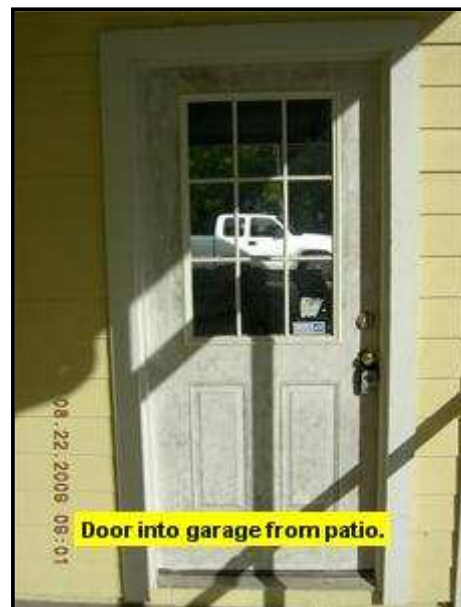
**2.2** Trim and casing of front door have been damaged. We suggest repair or replacement by licensed handyman. Door into garage from patio is extremely stained and has a crack on top left of window. Suggest replacement of door. The track systems for the sliding glass doors need to be cleaned. Dirt and debris need to be removed and lubrication is recommended as well.

Trim and casing of front door have been damaged. We suggest repair or replacement by licensed handyman. Door into garage from patio is extremely stained and has a crack on top left of window. Suggest replacement of door. The track systems for the sliding glass doors need to be cleaned. Dirt and debris need to be removed and lubrication is recommended as well.

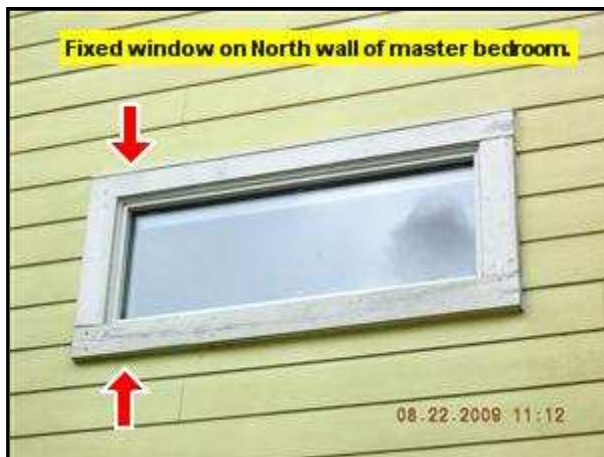
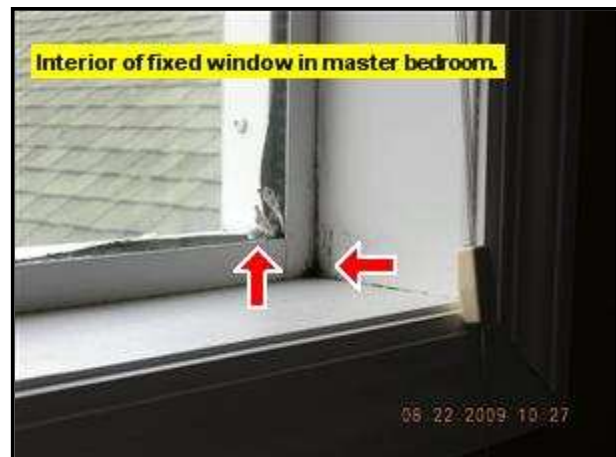
**2.3** We suggest licensed handyman to inspect flashing and caulking around fixed window on North wall of master bedroom and repair as necessary. Caulking around glazed window should also be repaired. There is evidence of water and insect penetration into the dwelling. See comments listed in Section 4 for more details.

We suggest licensed handyman to inspect flashing and caulking around fixed window on North wall of master bedroom and repair as necessary. Caulking around glazed window should also be repaired. There is evidence of water and insect penetration into the dwelling. See comments listed in Section 4 for more details.

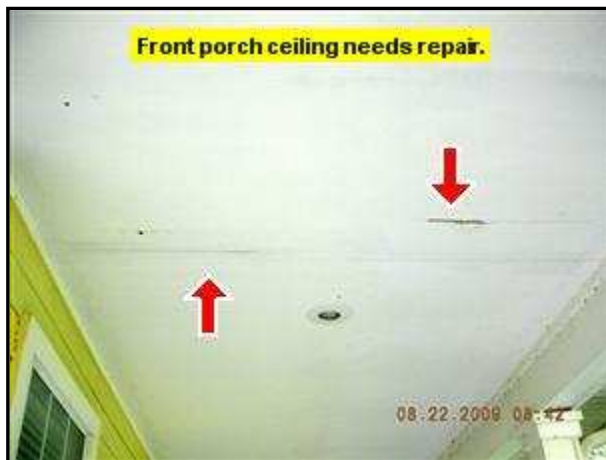
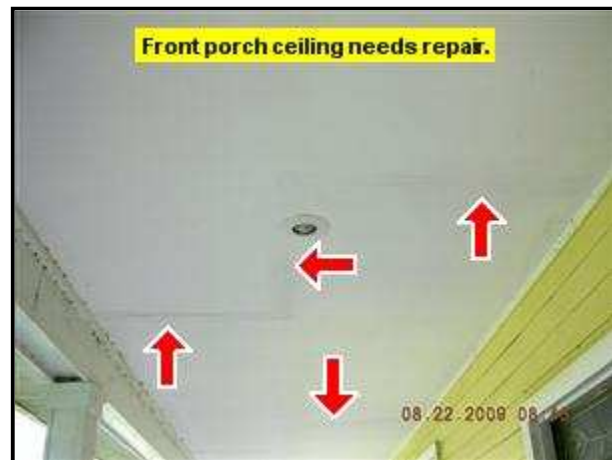
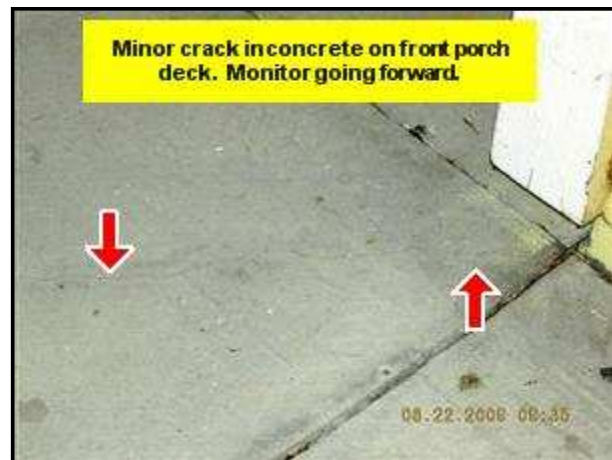
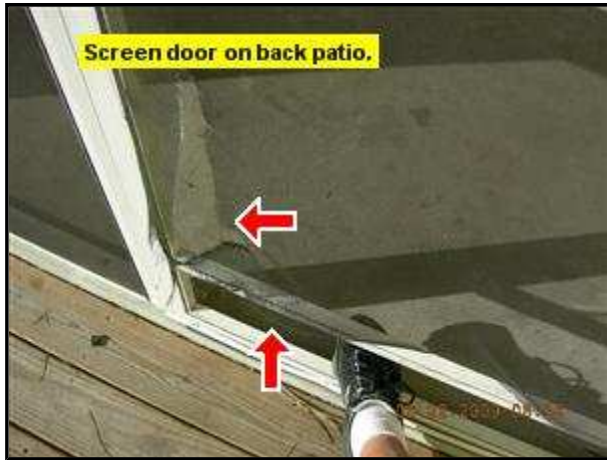
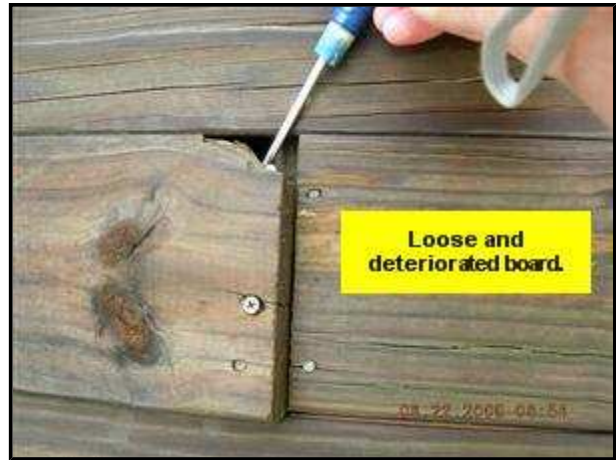
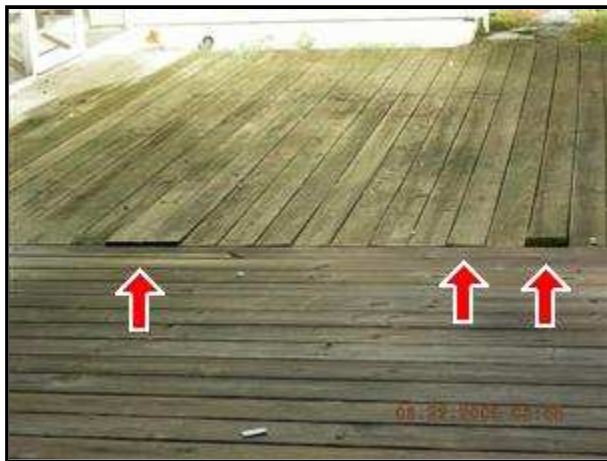
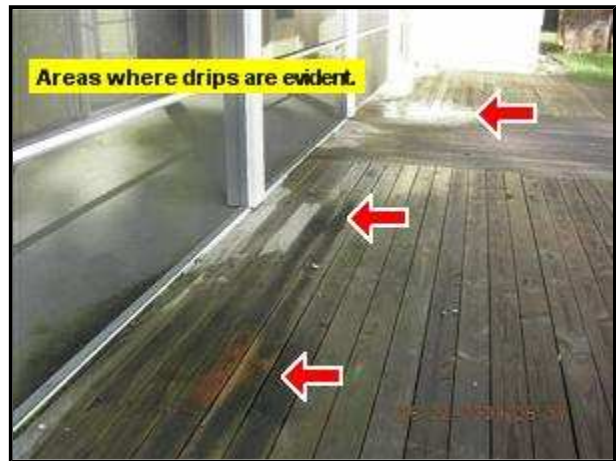
**2.4** Ceilings for covered porch areas on front and back are both in need of repair. We suggest a licensed handyman or drywall contractor to fill seam cracks and paint. Areas on front porch are mostly concentrated at seams suggesting damage is from moisture in the air and possibly faulty workmanship. Damaged area on back porch was caused by leak from flashing at chimney above. The screen enclosure on the back patio is in need of repair. The are rips and holes in the main screen areas and the door. The door latching components need to be replaced as they are worn and not functioning to their full potential. The wood deck in back is in need of repair. There are several areas where the boards are warped, loose or deteriorated. Suggest licensed handyman to remove and replace damaged boards. It is also suggested that during the repair of the deck that the downspout currently draining onto the deck be run through the deck onto the ground. We suggest directing the flow away from the concrete porch. The roof drainage system needs to be sealed at the seams to prevent dripping onto the deck. The deck system needs to be treated with a deck sealer to prevent further damage. The ends of the deck should also be sealed off to prevent animal intrusion.

Ceilings for covered porch areas on front and back are both in need of repair. We suggest a licensed handyman or drywall contractor to fill seam cracks and paint. Areas on front porch are mostly concentrated at seams suggesting damage is from moisture in the air and possibly faulty workmanship. Damaged area on back porch was caused by leak from flashing at chimney above. The screen enclosure on the back patio is in need of repair. There are rips and holes in the main screen areas and the door. The door latching components need to be replaced as they are worn and not functioning to their full potential. The wood deck in back is in need of repair. There are several areas where the boards are warped, loose or deteriorated. Suggest licensed handyman to remove and replace damaged boards. It is also suggested that during the repair of the deck that the downspout currently draining onto the deck be run through the deck onto the ground. We suggest directing the flow away from the concrete porch. The roof drainage system needs to be sealed at the seams to prevent dripping onto the deck. The deck system needs to be treated with a deck sealer to prevent further damage. The ends of the deck should also be sealed off to prevent animal intrusion.

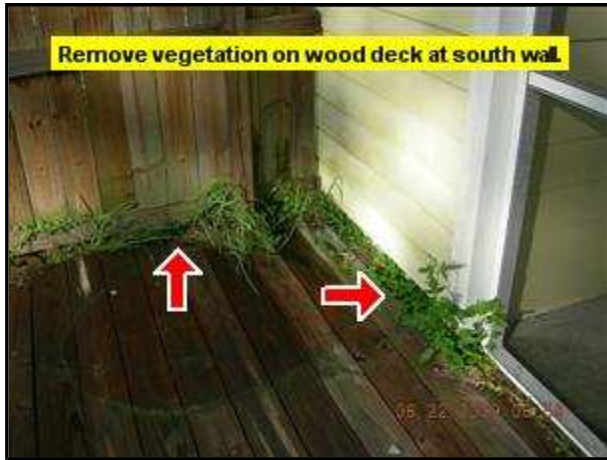
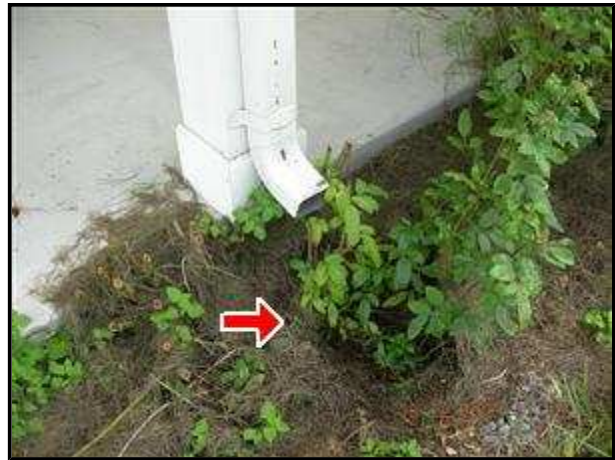
**2.7** Vegetation growing on wood deck at South wall should be removed to protect building and deck from moisture damage. Remove vegetation from area in front of downspout on front porch and install splash block.

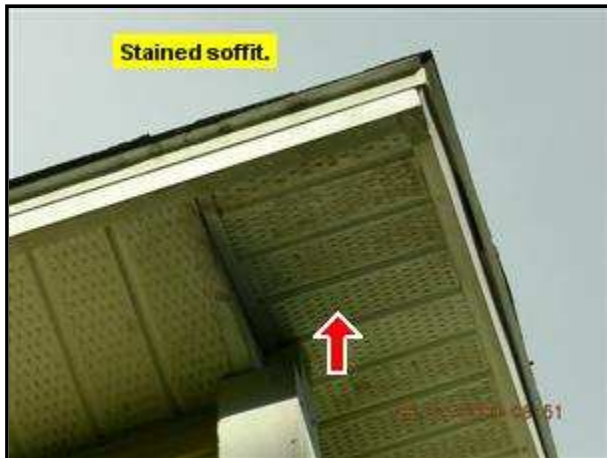
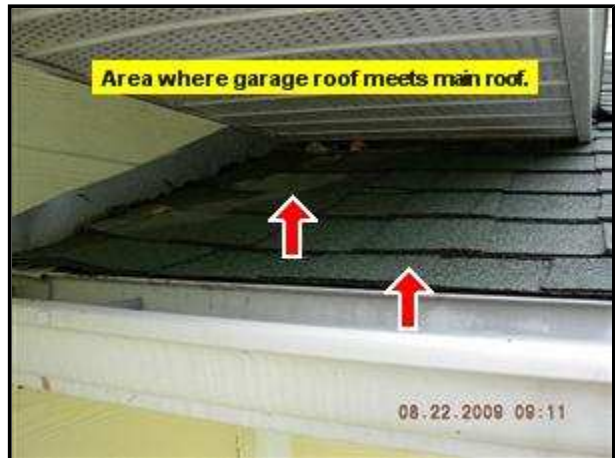
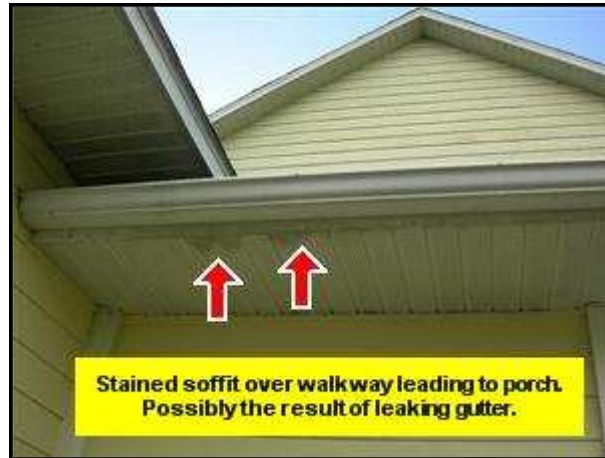
**2.8** Some areas on soffit are stained from moisture. Some of those areas may need addition of drainage system to control rain runoff. The area where garage roof meets main roof near walkway leading to porch may need to be addressed. The roof covering underneath the soffit of the garage roof was considerably moist. This may be caused by blowing rain from a storm the previous night. However, it may be the result of not having a roof drainage system on the garage roof to control runoff of rain water. A small piece of flashing has been used to attempt diversion of rain water coming from garage roof onto lower roof. A more substantial kickout may be necessary. The concern is excessive wear to roof covering from prolonged exposure to moisture. Lack of sun and wind do not dry this area as well as others areas. Summary: monitor for a chronic condition and consult with roofer if condition persists.

Some areas on soffit are stained from moisture. Some of those areas may need addition of drainage system to control rain runoff. The area where garage roof meets main roof near walkway leading to porch may need to be addressed. The roof covering underneath the soffit of the garage roof was considerably moist. This may be caused by blowing rain from a storm the previous night. However, it may be the result of not having a roof drainage system on the garage roof to control runoff of rain water. A small piece of flashing has been used to attempt diversion of rain water coming from garage roof onto lower roof. A more substantial kickout may be necessary. The concern is excessive wear to roof covering from prolonged exposure to moisture. Lack of sun and wind do not dry this area as well as others areas. Summary: monitor for a chronic condition and consult with roofer if condition persists.

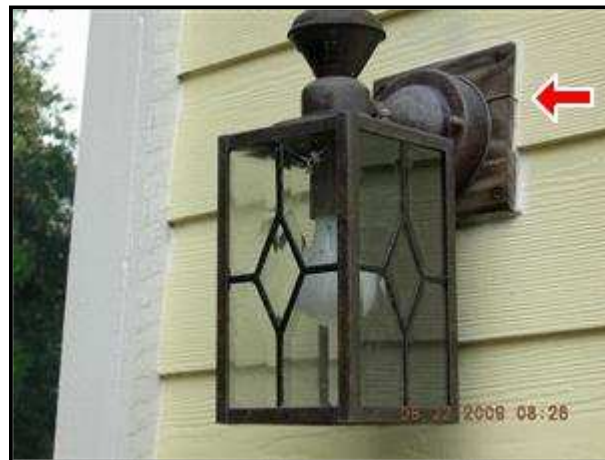
2.9 Picture 1

**2.9** The plates holding the coach lights on the garage door wall are all deteriorating and are cracked. This is due to the use of inferior material. These plates should be removed and replaced with material suitable to for exterior use and protected from the elements.

The plates holding the coach lights on the garage door wall are all deteriorating and are cracked. This is due to the use of inferior material. These plates should be removed and replaced with material suitable to for exterior use and protected from the elements.

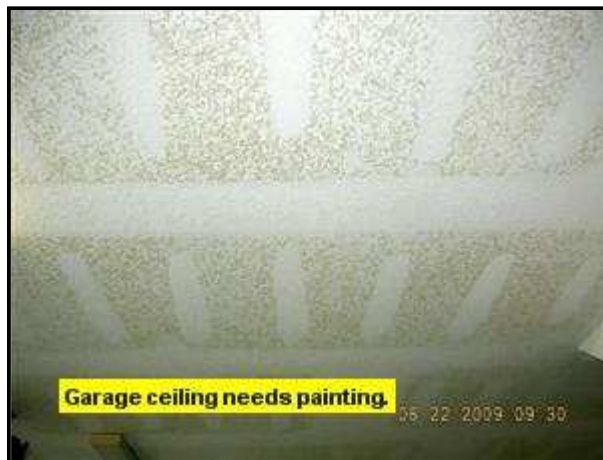
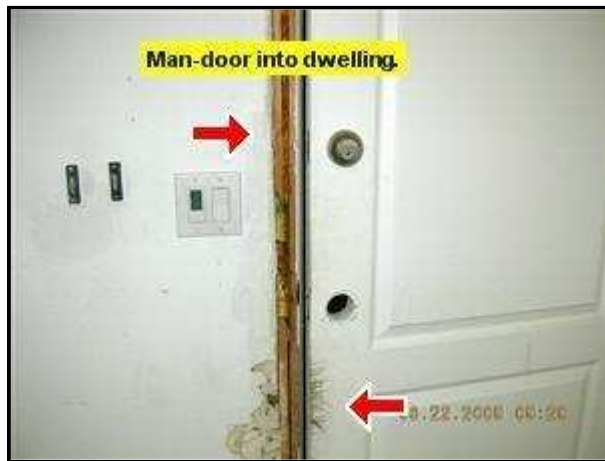
**3.0** The garage walls have some cosmetic damage and the ceiling is not painted. We suggest a licensed handyman or drywall contractor to make repairs to drywall. We suggest a licensed painter to paint the ceiling to enhance the protection of the drywall from ambient moisture. The automatic openers were tested and are operating as intended. The door leading to the main dwelling is in need of repair. As is the case with the front door, the trim and casing of the door has been damaged. We suggest a licensed handyman to repair as necessary.

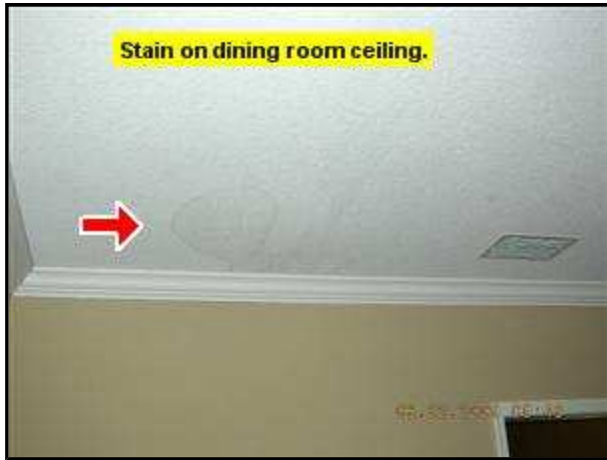
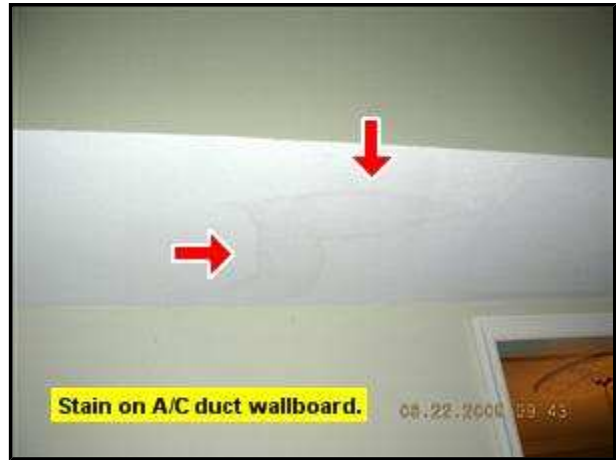
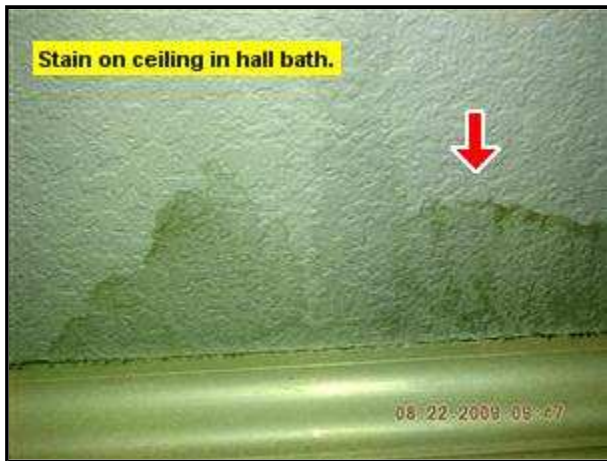
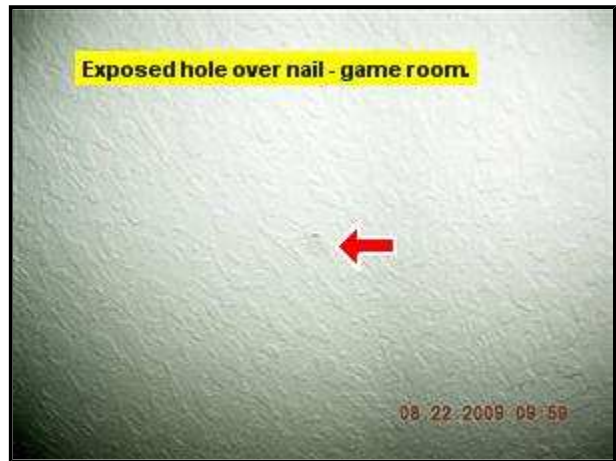
**4.0** Throughout the dwelling, there is evidence of cosmetic damage to the walls and flooring coverings. We suggest a licensed handyman or drywall contractor to repair or replace as necessary. Tested a sampling of windows and some were difficult to move. Suggest lubrication and adjustment as necessary. The blades on two ceiling fans have been removed. A door in the upstairs bedroom on the East side has been taken off its hinges and needs to be hung again. Although there are some minor repairs to make, there are some very nice features throughout the home as well. Crown molding and decorative features adorn the walls and ceilings in places.

Throughout the dwelling, there is evidence of cosmetic damage to the walls and flooring coverings. We suggest a licensed handyman or drywall contractor to repair or replace as necessary. Tested a sampling of windows and some were difficult to move. Suggest lubrication and adjustment as necessary. The blades on two ceiling fans have been removed. A door in the upstairs bedroom on the East side has been taken off its hinges and needs to be hung again. Although there are some minor repairs to make, there are some very nice features throughout the home as well. Crown molding and decorative features adorn the walls and ceilings in places.

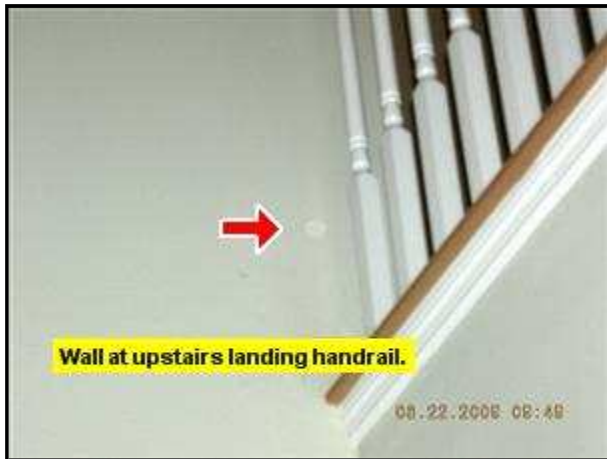
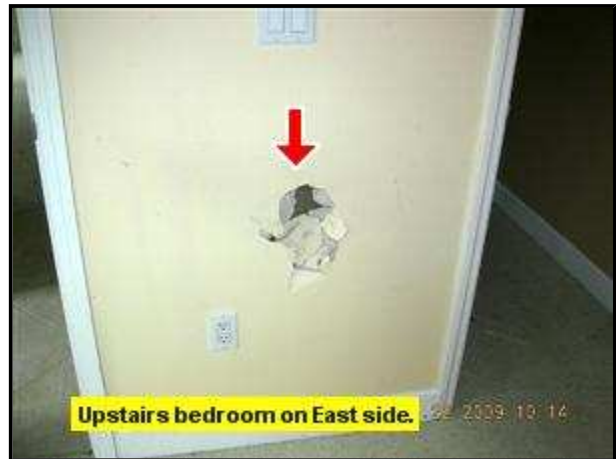
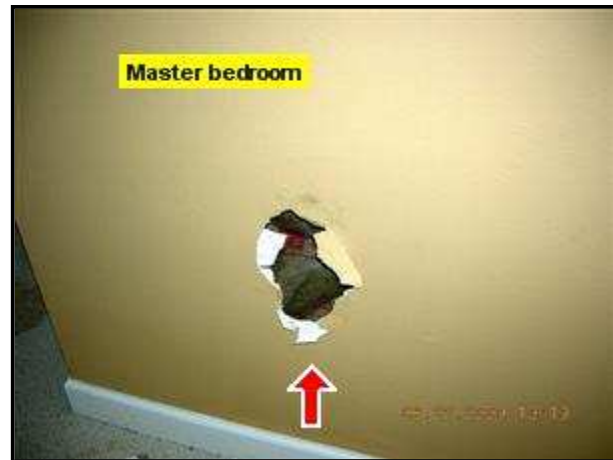
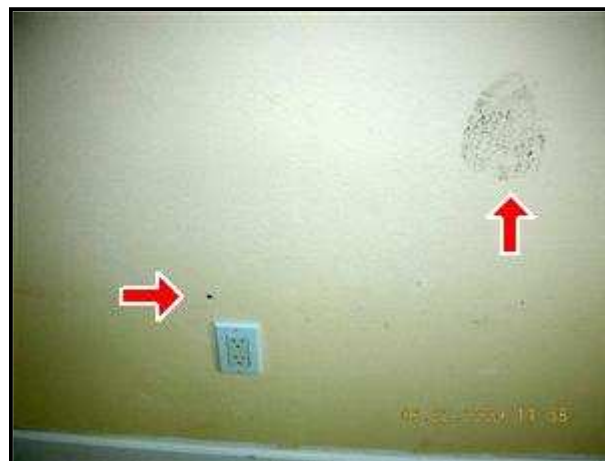
**4.2** There are several walls which are in need of repair.

There are several walls which are in need of repair.

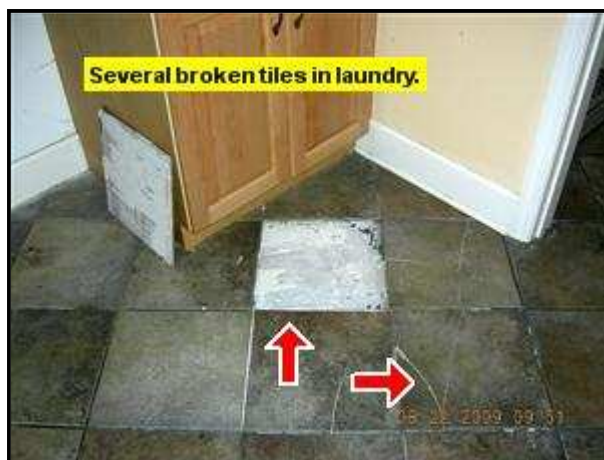
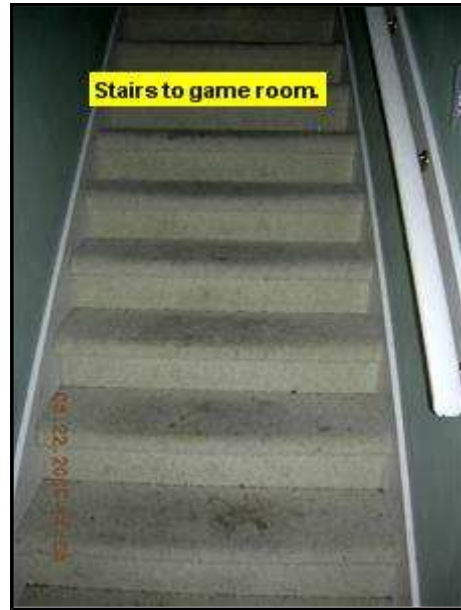
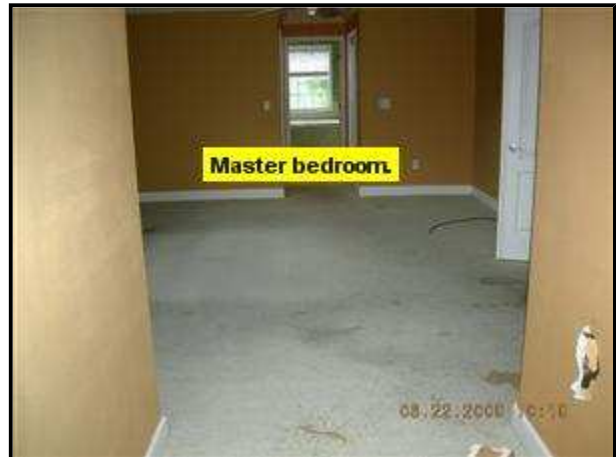
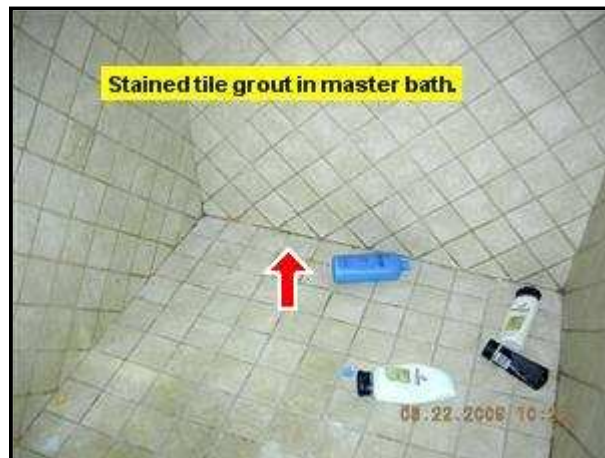
**4.3** We recommend that the carpet be replaced throughout the house. Stains and excessive wear were seen everywhere. The non-carpeted areas are acceptable with the exception of some damaged tiles in the laundry and soiled wood on the stairway leading to bedrooms. Some creaking was noticed in flooring system in upstairs bedroom on West side. When the carpet is replaced, it is suggested that the floor be inspected for any possible damage. More than likely, it simply needs additional nails or screws in the sub-flooring.

We recommend that the carpet be replaced throughout the house. Stains and excessive wear were seen everywhere. The non-carpeted areas are acceptable with the exception of some damaged tiles in the laundry and soiled wood on the stairway leading to bedrooms. Some creaking was noticed in flooring system in upstairs bedroom on West side. When the carpet is replaced, it is suggested that the floor be inspected for any possible damage. More than likely, it simply needs additional nails or screws in the sub-flooring.

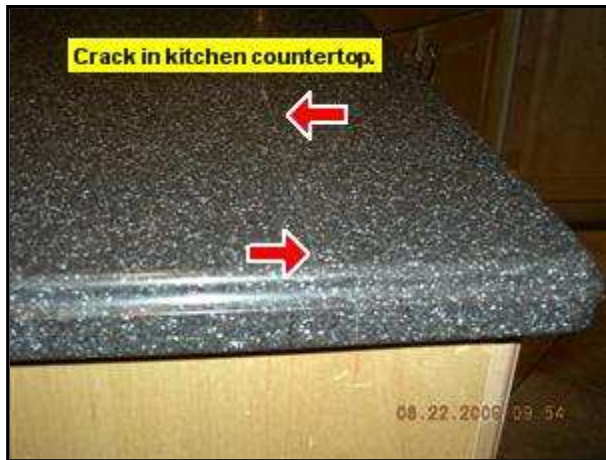
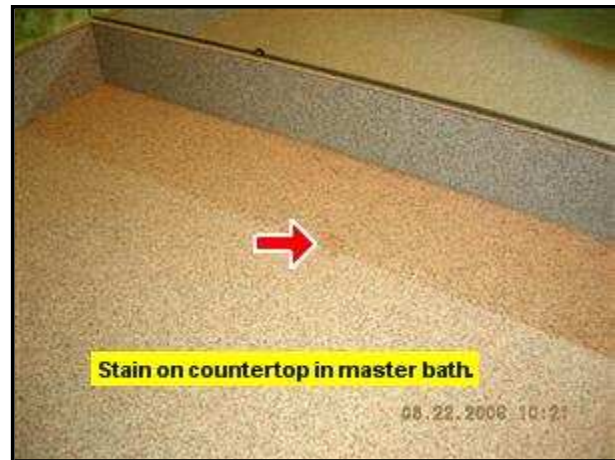
**4.5** Kitchen countertop has a crack. Suggest cabinet company to inspect for possible repair or replacement. Cabinet doors on section to left of windowed cabinet in corner need adjusting.

Kitchen countertop has a crack. Suggest cabinet company to inspect for possible repair or replacement. Cabinet doors on section to left of windowed cabinet in corner need adjusting.

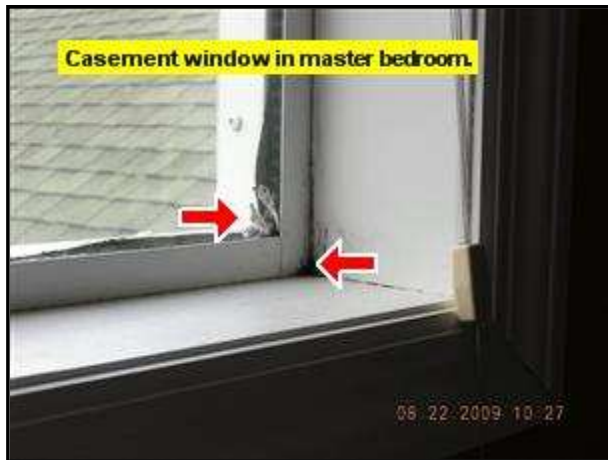
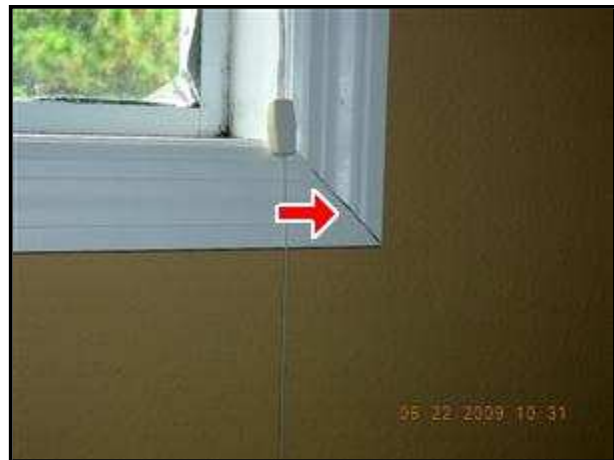
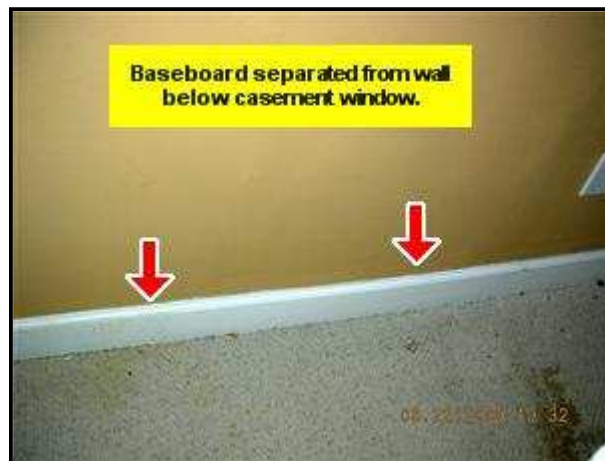
**4.7** The window in the master bedroom needs attention. The trim, flashing and siding on the outside need to be inspected for serious deterioration. If just routine, then those components need to be caulked and painted to prevent rain water from penetrating. The putty holding the glazed window in place appears to not be preventing moisture penetration as well. We suggest a licensed handyman to add silicone caulking to glazed window - especially in bottom right corner as shown in picture. When a moisture meter was used to measure the affected area, it read 46% for moisture content of the sill/trim wood material. Evidence of staining on the wall and baseboard separation below the window was found. Also saw ants in same corner of window.

The window in the master bedroom needs attention. The trim, flashing and siding on the outside need to be inspected for serious deterioration. If just routine, then those components need to be caulked and painted to prevent rain water from penetrating. The putty holding the glazed window in place appears to not be preventing moisture penetration as well. We suggest a licensed handyman to add silicone caulking to glazed

window - especially in bottom right corner as shown in picture. When a moisture meter was used to measure the affected area, it read 46% for moisture content of the sill/trim wood material. Evidence of staining on the wall and baseboard separation below the window was found. Also saw ants in same corner of window.

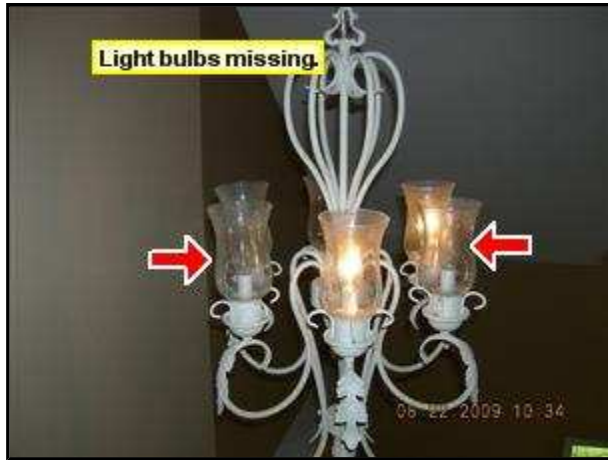
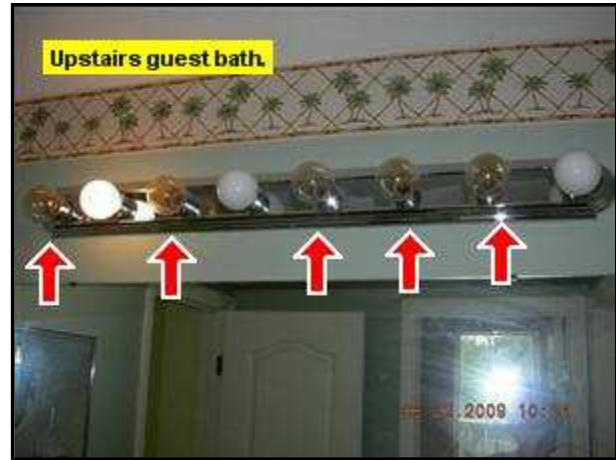
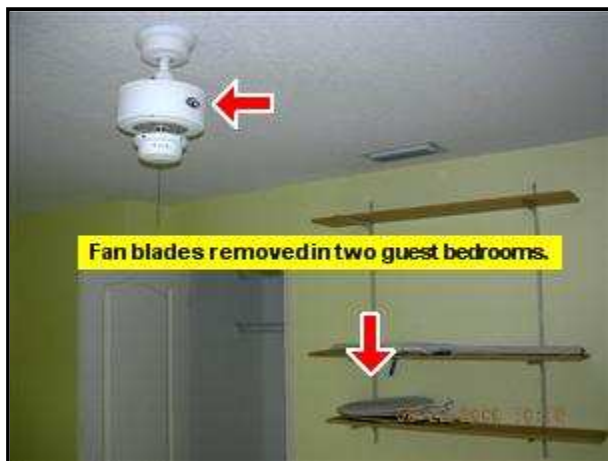
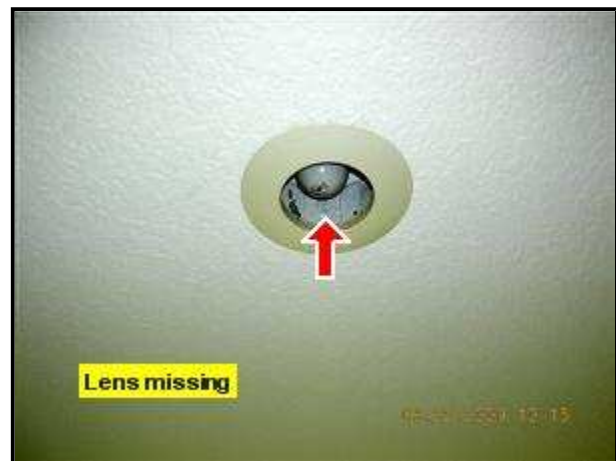
**7.0** There are 4 GFCI circuits in the dwelling. One of them on the East garage wall needs repair - the Hot and Ground wires are reversed and the GFCI component will not function as intended. There are 3 outlets on that circuit. We suggest a licensed electrician to repair this. GFCI circuit for upstairs and downstairs guest bathrooms are linked. Reset button is in upstairs bathroom. Floor outlet in living room not hooked up. Some of the smoke detectors are missing. Several light bulbs were not functioning in various rooms throughout the house.

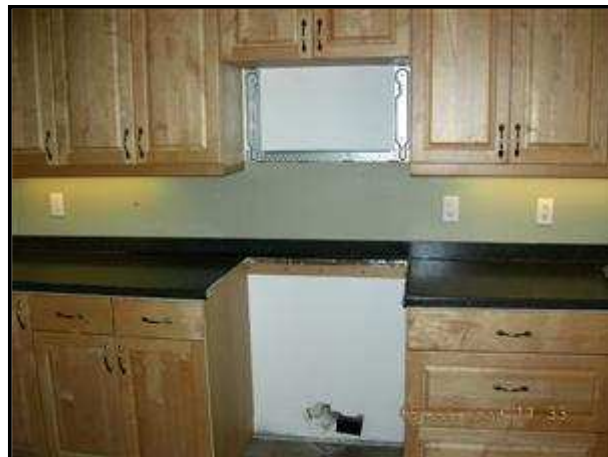
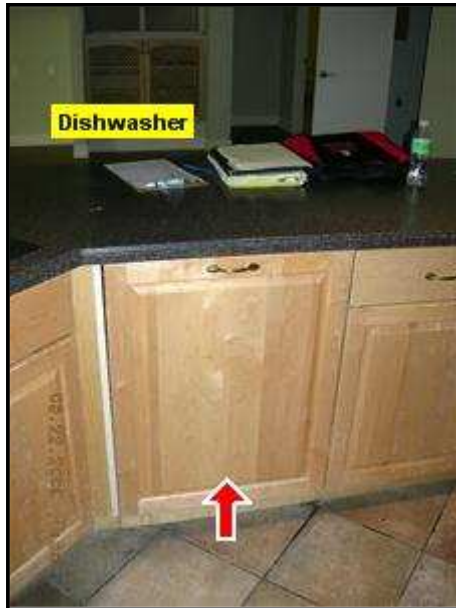
**10.0** All appliances were missing except dishwasher and disposer.
